Sunnyside Cogeneration Associates

RE: Fourth Quarter 1999 Inspection Report

Please find enclosed a copy of the Fourth Quarter 1999 Inspection Report for Sunnyside Cogeneration Associates' impoundments, refuse pile and excess spoil areas. The inspection was performed by a professional engineer from Psomas and Associates Engineering.

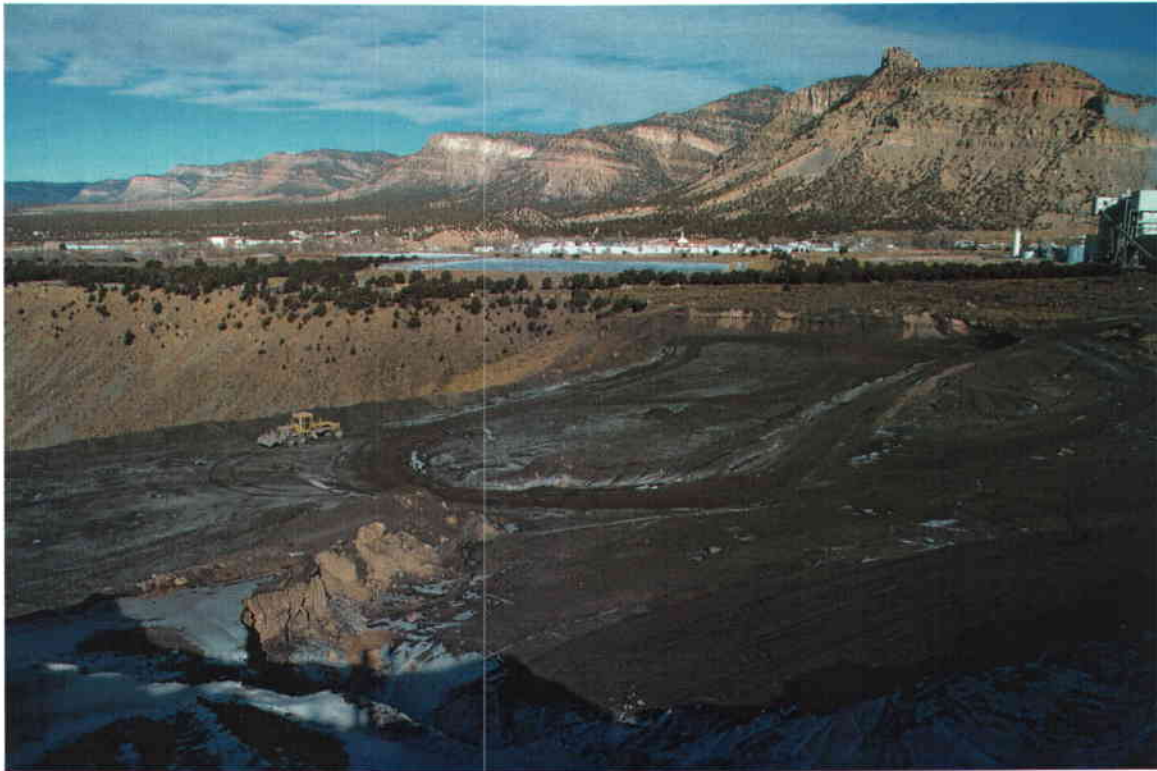
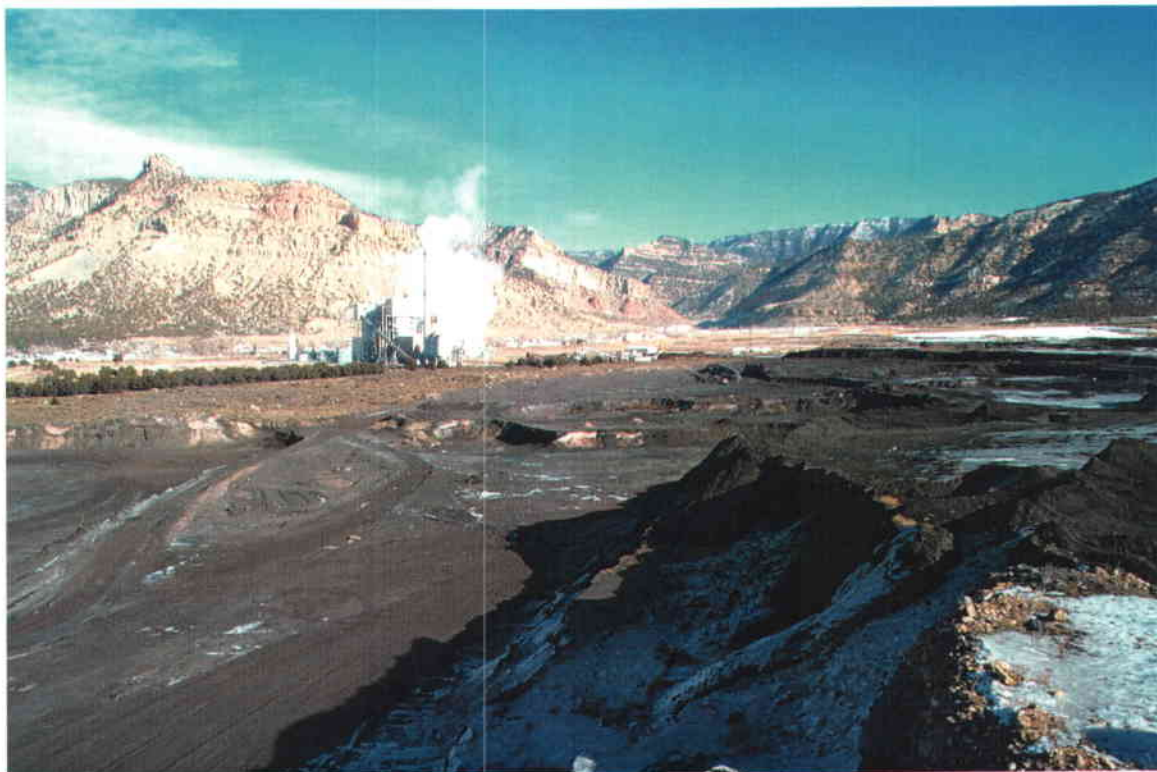
Coarse Refuse Pile
12/22/99

Excavation of refuse material damaged a small portion of the westerly access road around the refuse pile. The operator was notified and agreed to repair the road and adjacent ditch and berm.

One Smoker was observed at the north edge of the pile. This was brought to the attention of the operator who indicated an intent to extinguish is immediately.
